Navajo Abandoned Uranium Mine

Site Screen Report

Mesa VI Mine AUM Site

Navajo AUM Northern Region

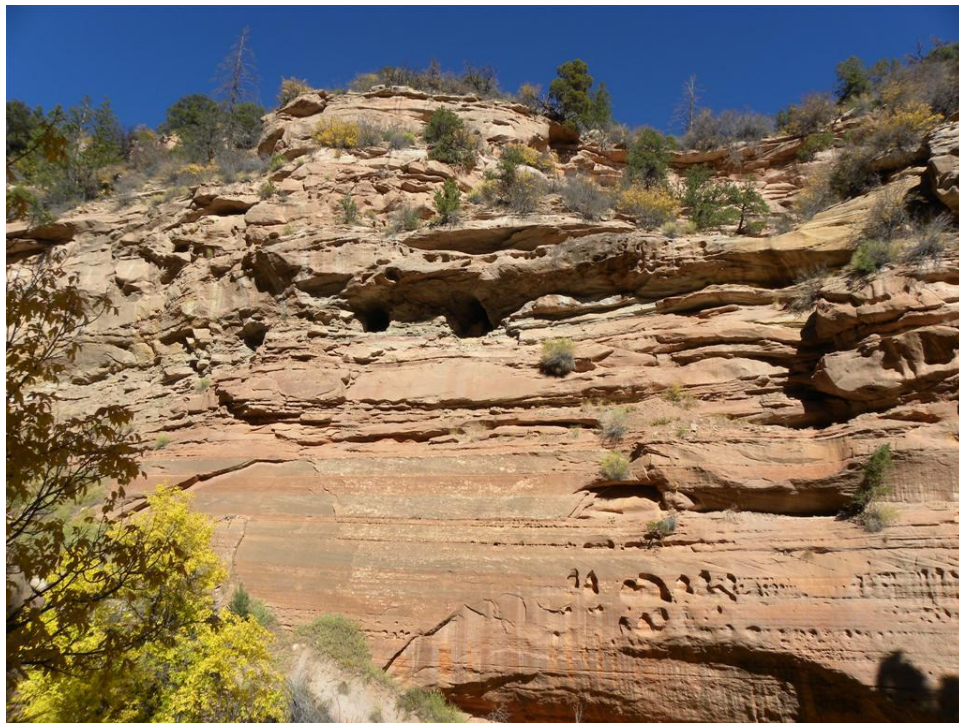
One sealed adit; two open inaccessible adits

Photo 1. Cliffside adits

1 sealed adit; 2 inaccessible open adits with mining debris; unreclaimed waste pile

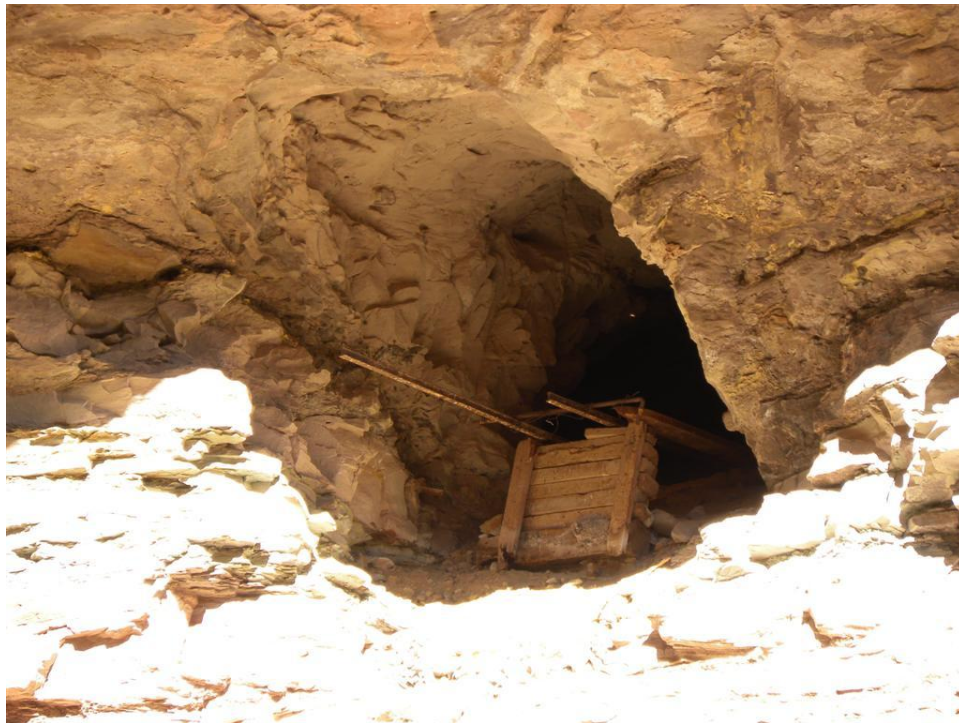
Mining tracks and rails extending from adits

Photo2. Tracks protruding from adit

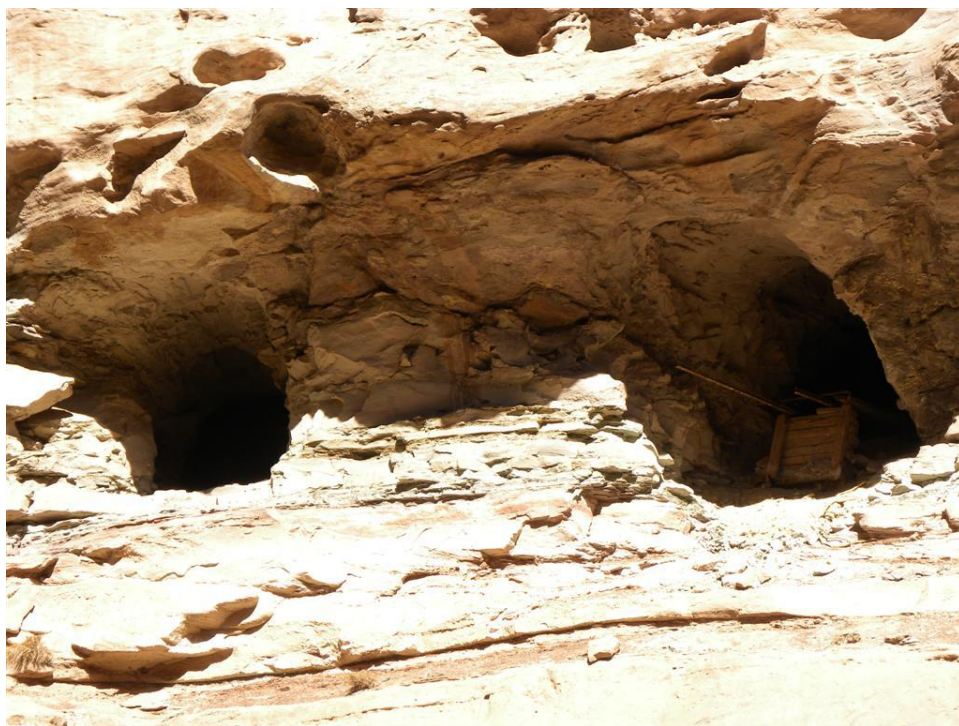
Photo 3. Cliffside open adits

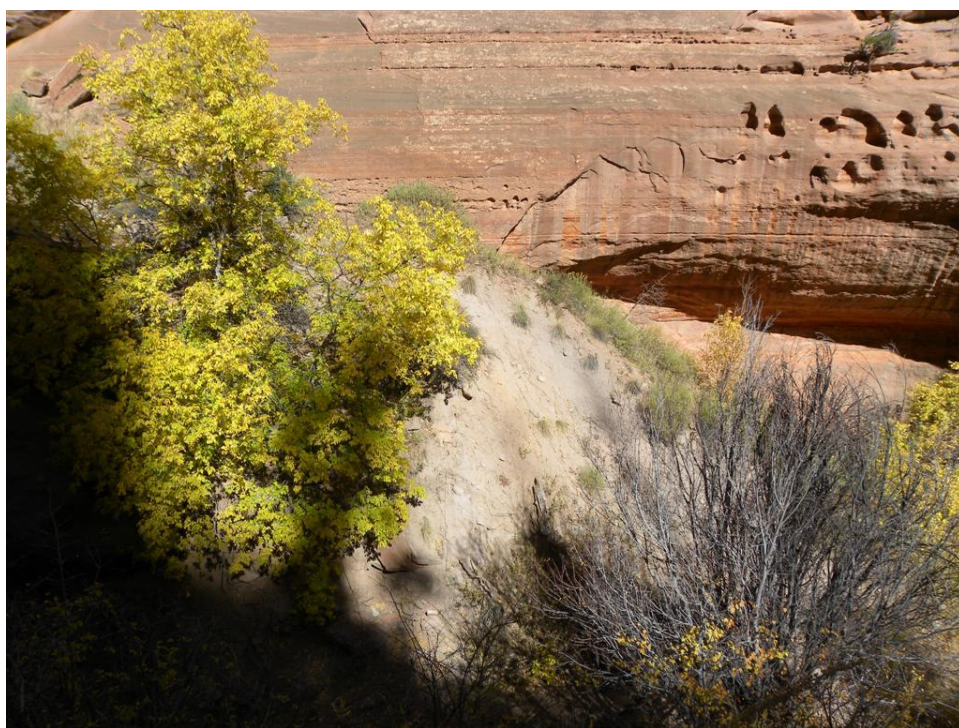
Waste piles extending down slope to creek, 250' x 50', with a total estimated volume of 2,315 yd³

Photo 4. Waste pile

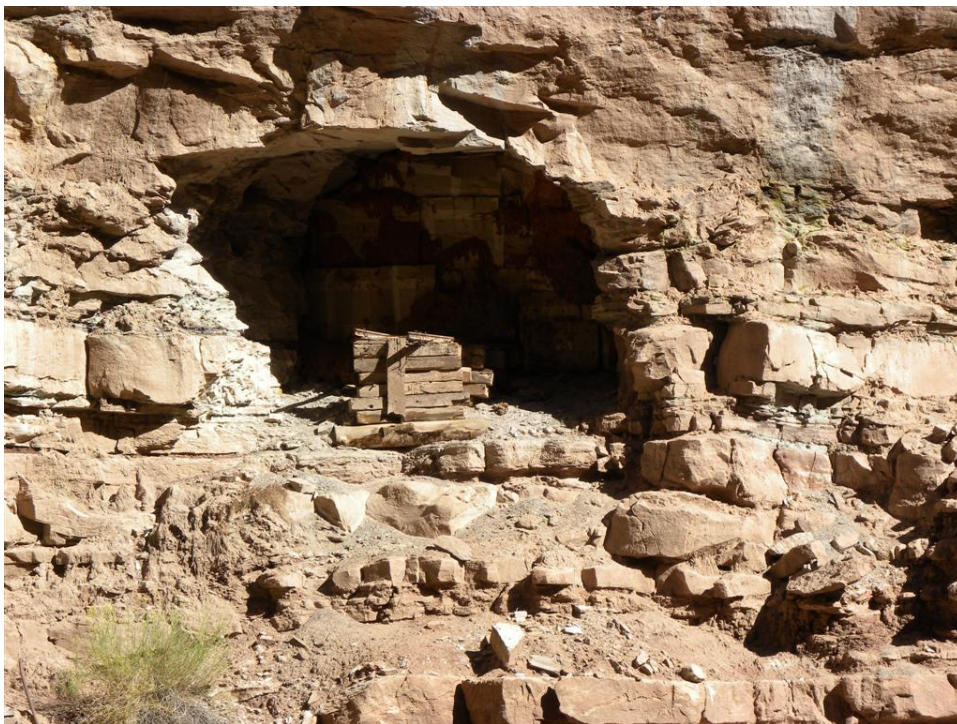
A total of 1,817 gamma radiation measurements were collected from the mine site, ranging from 10,135 cpm to 655,527 cpm. Measurements in the vicinity of the waste debris were found at levels in up to 150,000 cpm, and at the sealed adit at levels up to 650,000 cpm. Due to poor satellite coverage, the gamma reading locations were not mapped by the GPS. A site layout is shown in Figure 1.

Is the cap/seal functionally intact? Yes

Is the cap/seal sufficiently degraded to create a concern about releases? No

Photo 6. Sealed adit

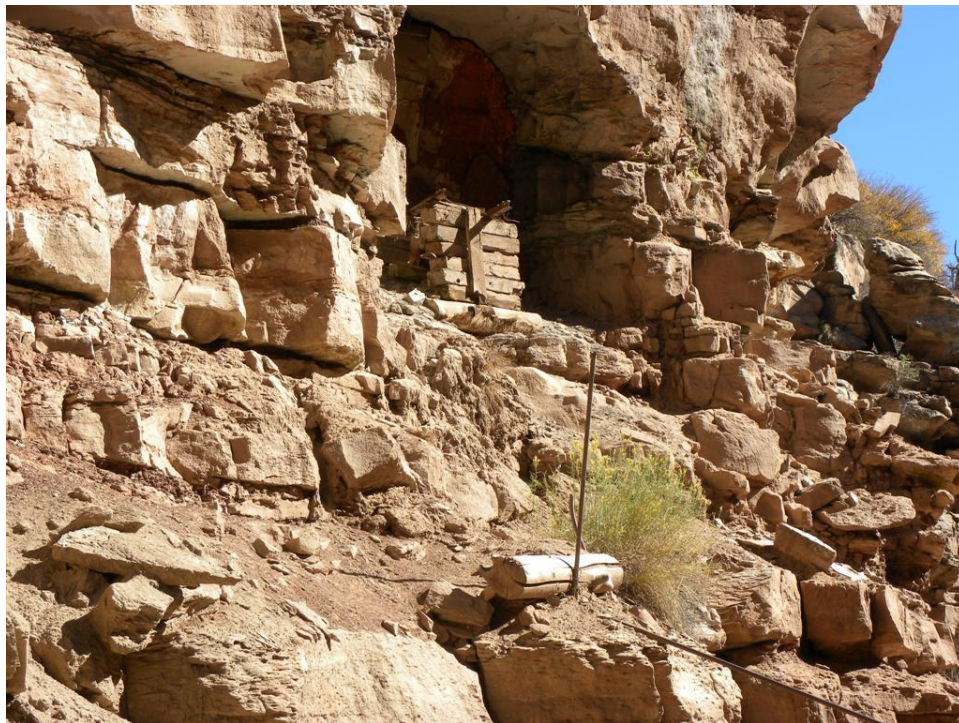
Photo 7. Sealed adit
